# Analysis of Morphometric Traits and Ecological Threats in Stubbs Creek Forest Reserve, Akwa Ibom State, Nigeria

This study was conducted in Stubbs Creek Forest Reserve, (SCFR) Akwa Ibom State, Nigeria. The aim was to analyse the morphometric traits of this area, using some relevant terrain attributes (elevation, slope and aspect) in ascertaining areas threatened by significant ecological problems such as flood, erosion and others. In terms of method of study, a digital elevation model (DEM) was purchased as a raster with longitude and latitude; geo-referenced, but re-projected to WGS, UTM zone 32 N in order to enhance data integration into the GIS interfaces. The surface operation tool of ArcGIS 9.3 spatial analyst extension was used to extract the different layers being elevation, slope and aspect. These were subjected to reclassification function in the same software to harmonise

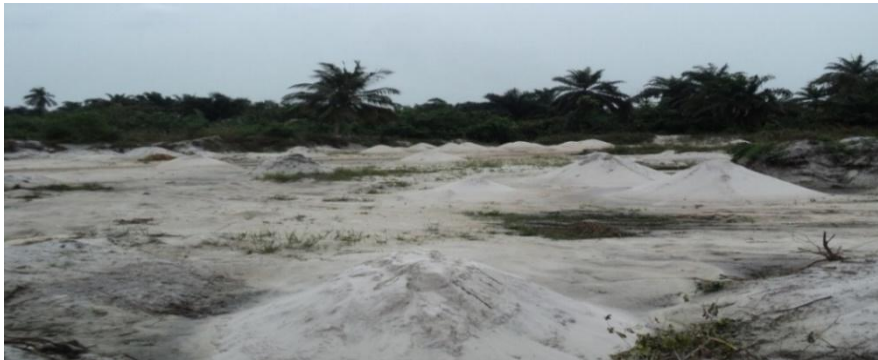
**Fig. 5. Sand mining site within the beach ridge complex environment in SCFR culminating into surface scars, gullies, and siltation of streams and wetlands**  
 Source: Researchers' Fieldwork (2022)

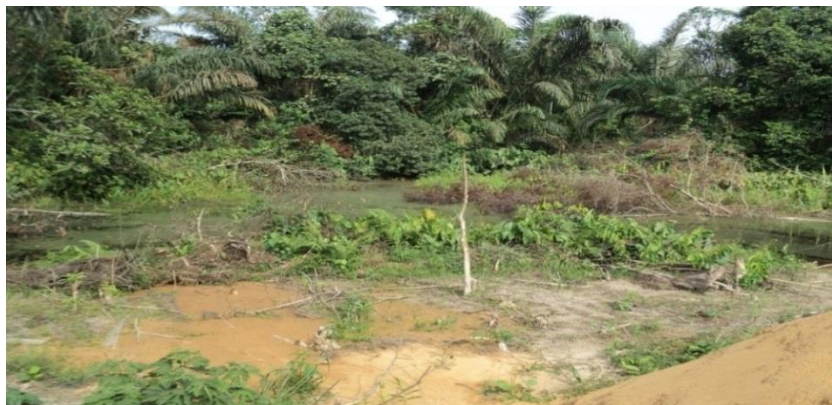
**Fig. 6. A sand mining site within the beach ridge complex environment in SCFR culminating into flooding, erosion and siltation of streams and wetlands**  
 Source: Researchers' Fieldwork (2022)

The Beach Ridge Complex covers most parts of Eket, Ikot Abasi and part of Oron Local Government Areas. Just northward of the shoreline to about 10 kilometres inland is a strip of land characterized by a succession of parallel land, sub-parallel ridges of recently deposited marine sands as explained by Usoro [38]. East of Upenekang, the sand ridges are remarkably straight, and up to 400 metres in width. Okorote area is also characterized by straight sand ridges. The mediating swales are reflected in major lineation of vegetation of thick raffia shrubberies which contrasts especially from the spare scrub on the sand edges. The mean amplitude of the sand ridge is 30 metres rising to 50 metres at its northern boundary [41,38]. According to Usoro [38] farming and other activities which expose the land cover to ecological problems should be restricted on the sand ridges ban. This terrain type is very predominant in the study area. It is dissected in a north-south direction by the Stubbs and Widenham creeks as shown in Fig. 4. As indicated in Figs. 5, 6 the incessant and indiscriminate anthropogenic activities such as farming and sand mining in the Edo, Esit Eket axis of the study area had led to the pulled away effect of the mined sand thereby resulting in ecological problems such as surface scars, erosion, gullies, siltation of streams, rills, tributaries, wetlands and habitat fragmentation (Figs. 6 and 9).

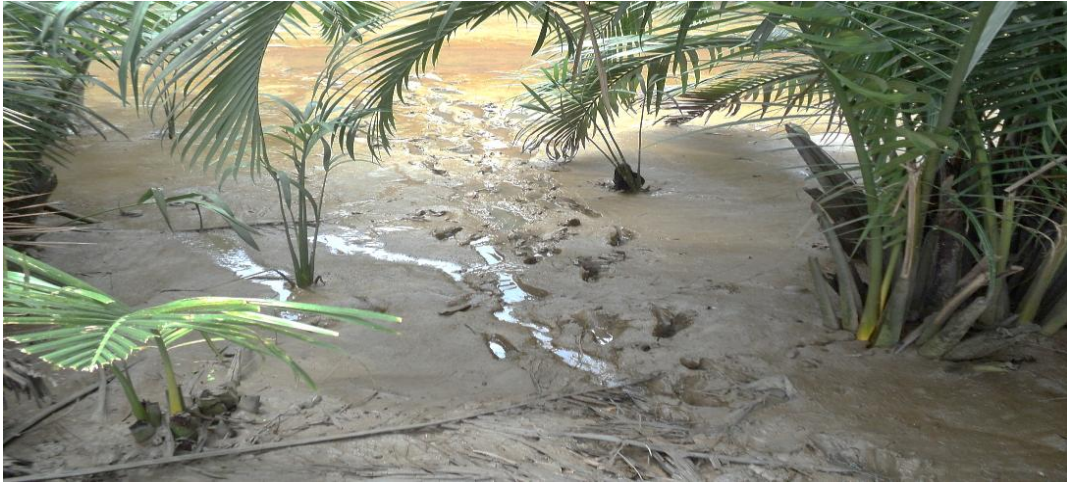
**Fig. 7. A degraded alluvial plain environment in the study area prone to flooding**  
*Source: Researchers' Fieldwork (2022)*

During the researchers' fieldwork, it was observed that the terrain characteristics of SCFR around Cross river estuary was liable to flooding (Figs. 4 and 7). In essence, the whole of the east front of this area was inundated. Accordingly, the same flood scenario dominated the west end of SCFR, in which there had been incessant exploitation of *Rhizophora* species utilized mainly for fish drying and hot drinks (ufop) distilling. This has created room for foreign bodies to intrude into this sensitive environment as well as other ecological problems such as habitat destruction, enrichment of heavy metals and soil contamination (Fig. 7).

Consequently, Alluvial Plain sands with Mangroves is one of the terrains in this area threatened by deplorable ecological problems such as flood, habitat fragmentation, erosion and soil contamination. Coastal flooding is one of the ecological problems affecting this terrain class as reported by Usoro [38]. This area has a gently flat surface and is criss-crossed by numerous creeks mostly at the eastern and western ends, which make larger part of it inundated in most parts of the year. More so, this area has lost a greater amount of its vegetation, especially *Rhizophora* species thereby subjecting it to severe ecological threats such as flood and so on as shown in Figs. 4 and 7. This is in agreement with Ekpenyong et al. [48] who

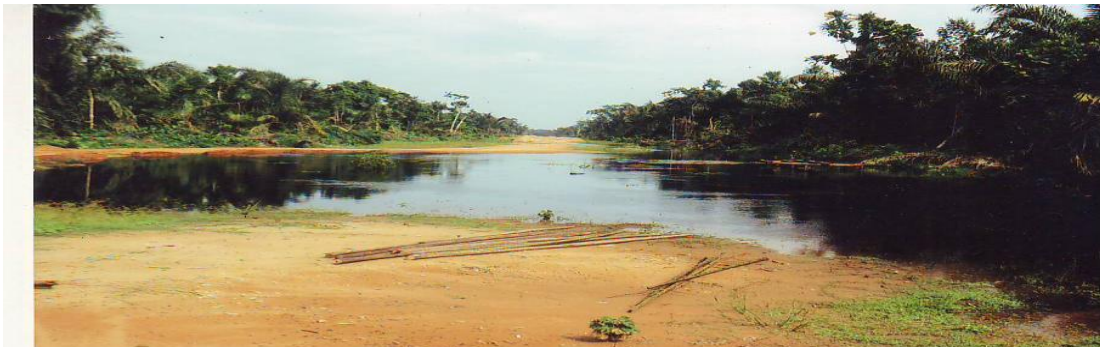
**Fig. 8. A typical eroded and flooded area in SCFR**  
*Source: Researchers' Fieldwork (2022)*

Okposo and others. This makes development very difficult in spite of the oil-rich economy of this area. As observed during the researchers' fieldwork, areas where vegetation was cleared

for either, road construction, farming and so on were prone to erosion resulting in land degradation, siltation of streams, tributaries, wetlands and habitat fragmentation (Fig. 8).

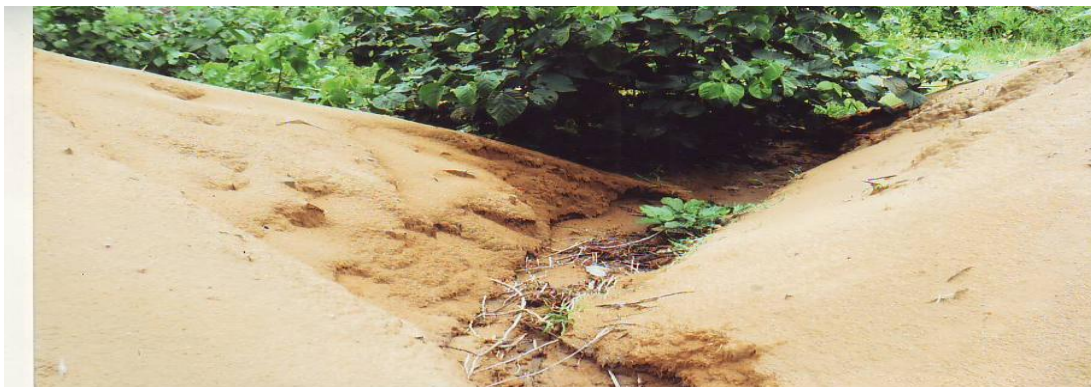
**Fig. 9. An eroded point in SCFR leading to land degradation, siltation of streams, tributaries wetlands and habitat fragmentation**  
*Source: Researchers' Fieldwork (2022)*

In the southernmost part of the study area, most of the settlements here were threatened by coastal erosion (Figs. 3 and 9). Such settlements include Inua Eket, Ikot, Nditto Eka Iba, Atia, Itak Afaha, Ine Akpautong, Eto Esek, Okom Ita,
